Subject: Geotechnical Investigation Report

Spence and Syed New Residence 14180 Northwest Germantown Road Portland, Multnomah County, Oregon

EEI Report 21-156-1-R1

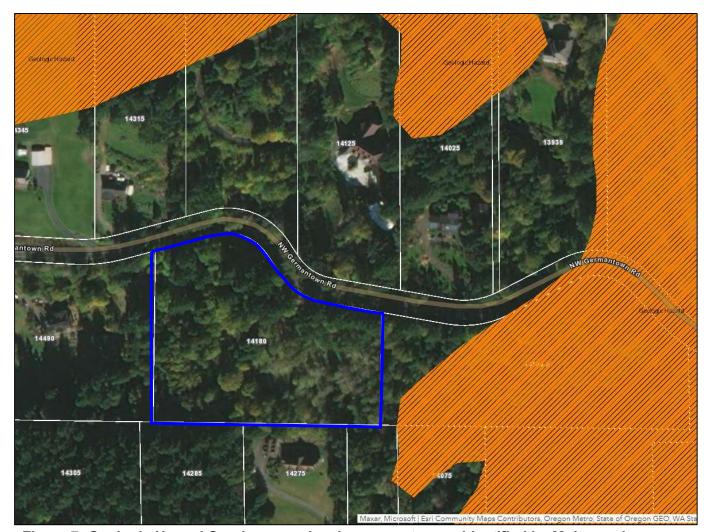
Figure 7: Geologic Hazard Overlay map showing nearest areas identified by Multnomah County Land Use Planning. The property tax lot boundaries are shown and the proposed home tax lot is outlined in solid blue (base image source: https://www.arcgis.com/apps/webappviewer/index.html?id=9c6906dd2ff1459b9d6c7d0a0de4afb2, accessed November 29, 2021).

In our opinion, the home construction does not trigger a Geologic Hazards Permit requirement per the "Geologic Hazard highlighted notes from Prefile Meeting PF-2021-14574 Notes Final.pdf," (1-page) and the "highlighted hillside development permit_handout.pdf," (2-pages) from Karina Adams. These documents discuss two triggers for a Geologic Hazard, 1) if development will occur within the County's mapped hazard areas identified on the Geologic Hazard Overlay map, or 2) if development will occur on land with an average slope of 25-percent or more. Based on our review of two other documents from Karina Adams on November 28th which show the Multnomah County Geologic Hazard Overly map, and our review of the map (accessed November 29th, 2021), the Geologic Hazard Overlay zones do not extend onto the subject property tax lot. Figure

7 shows the Multnomah County Land Use Planning-Reference Map with the Geologic Hazards overlay. Also, based upon the topographic survey of existing conditions, presented on the Site Plan, A1.0, by Karina E. Adams Architect, dated October 27, 2021 and November 10, 2021, the proposed house location is not situated on a slope of 25-percent or steeper.
