HomeTeam® INSPECTION SERVICE

9 Banahasky Ln

Inspection #: 527-092024-5924

HOME INSPECTION REPORT

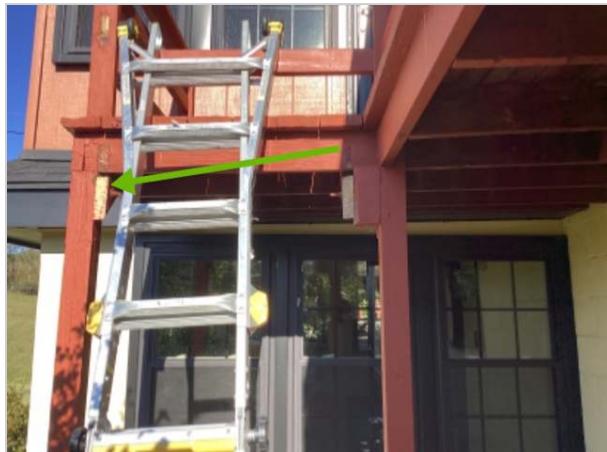
Slope to left

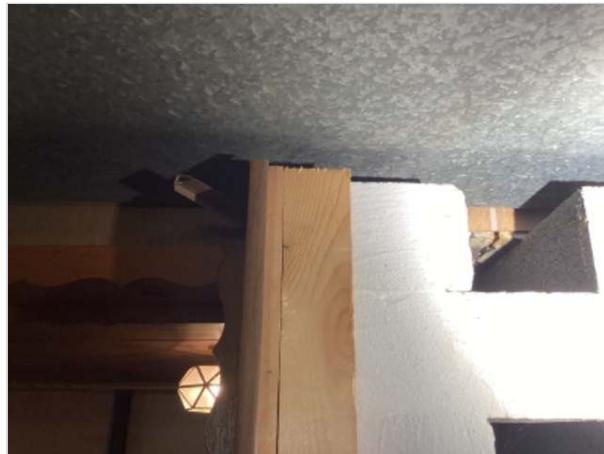
Evidence of termite activity was noted on the band joist and floor joists. The visible damage could not be thoroughly inspected due to the covered structure. Please note too that any assessment as to the extent of damage caused by termites is limited to the visible and readily accessible areas of the home. We are not able to determine the presence or extent of concealed damage.

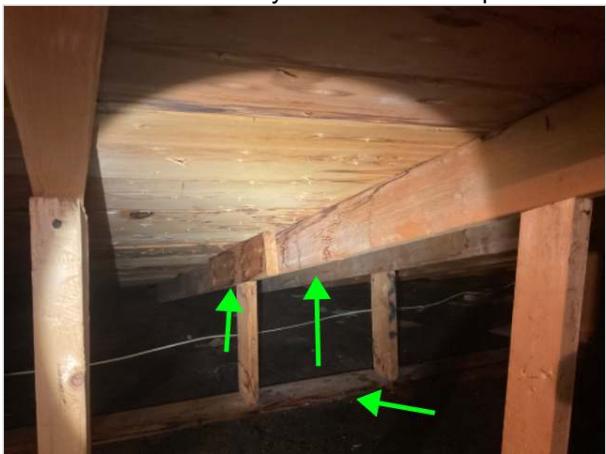
All of the vertical support purlins are based on the original roof.. The purlins are an important structural component and should be properly supported. It is our recommendation to consult with a qualified contractor to confirm the structure is adequate.

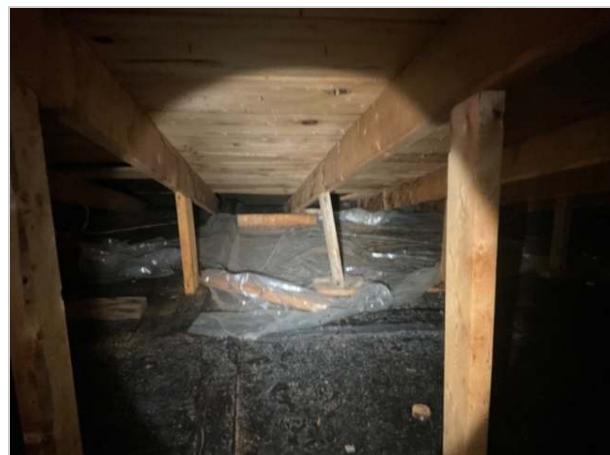
examples of questionable and out of plumb support

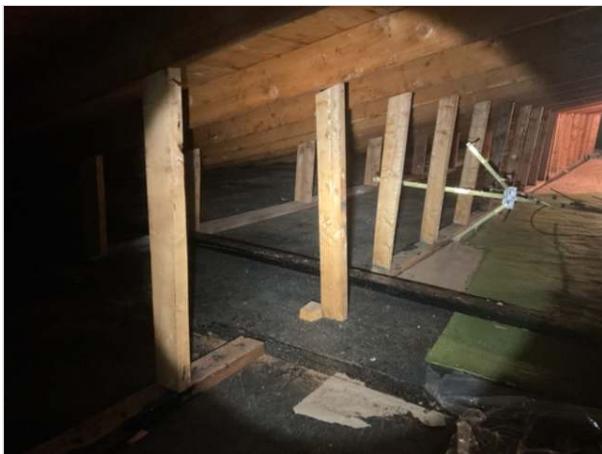
examples of questionable and out of plumb support

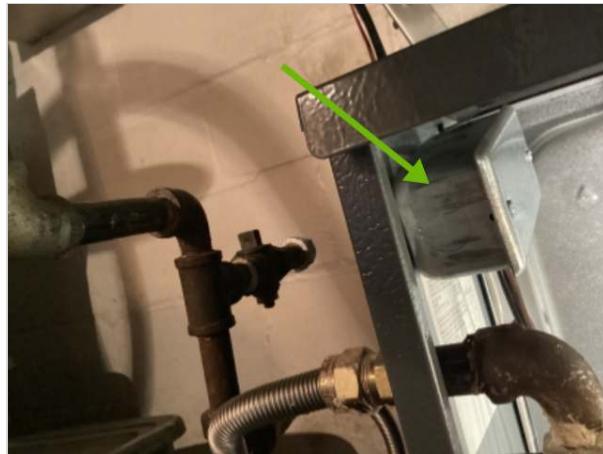
Power box on tag
